**PHASE I REPORT
NATIONAL DAM SAFETY PROGRAM**

Name of Dam: Verona Lake Dam, NJ00386
State Located: New Jersey
County Located: Essex
Drainage Basin: Passaic River
Stream: Peckman River
Date of Inspection: November 14, 1979

**PHASE I INSPECTION REPORT
NATIONAL DAM SAFETY PROGRAM**

VERONA LAKE DAM, I.D. NJ00386

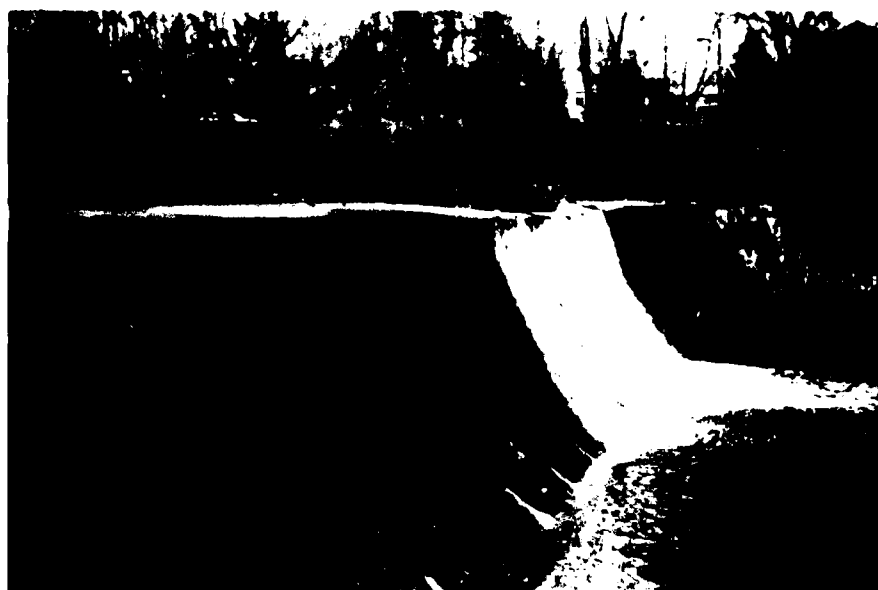
PHOTO 3

The masonry overflow portion of the dam comprises the spillway. The crest of the spillway is formed with a depressed section at the center where most dry weather overflow occurs. Several areas of leaching were observed on the downstream face near the toe of the spillway. Some leachate did not appear to be composed of soil, but appeared to contain deteriorated mortar. Evidence of leakage was observed

discharging immediately below the concrete cap which forms the spillway crest. The stone masonry training walls appeared to be in good condition with small amounts of patching near the top.

LEAKAGE AT CREST OF SPILLWAY
